LISTER LH150 GEARBOX ADJUSTMENT

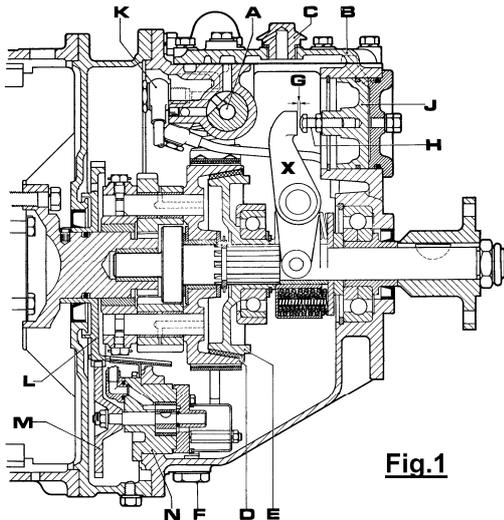
Fig.1

This is especially important with regard to the clearance on the forward drive extraction linkage (dimension "G" on fig.1) since the action of the gearbox is that the forward drive cone is held in engagement with the clutch body by a spring pack and it is only disengagement that is effected by hydraulic pressure. If the clearance at "G" is not present there is a probability that the drive cone may be held slightly out of engagement causing slip and excessive wear to the clutch lining.

A clearance at "G" may be verified by removing the filler cap "C" and inserting a screwdriver between the bolt "H" and the operating lever "X".

If this is not the case, the gearbox top cover must be removed for necessary adjustment to be made to the recommended value of $\frac{3}{32}$ " (2.38mm).

To adjust – using $\frac{3}{4}$ " a/f spanner to prevent piston "J" from rotating, loosen lock-nut ($\frac{1}{2}$ " a/f) on bolt "J". Ensuring that piston is pushed fully to rear of box, adjust position of this bolt to give recommended clearance and lock in position with nut.

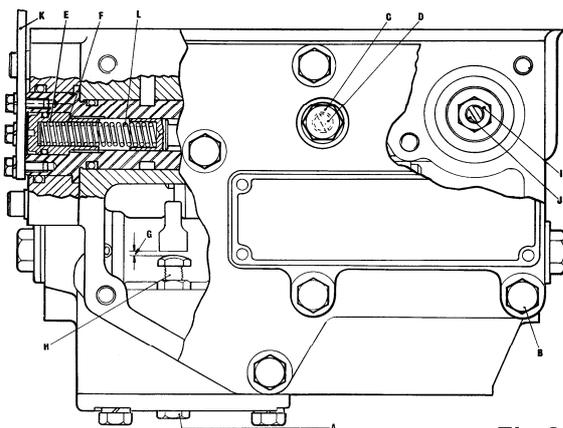
Fig.2 shows the Reverse band operating spindle "J" and lock-nut "I", visible when gearbox cover is removed.

Hold the slotted end of the spindle in position with a screwdriver and using a $\frac{1}{2}$ " a/f spanner, tighten the lock-nut until the band securely grips the clutch body.
