LISTER LH150 GEARBOX ADJUSTMENT

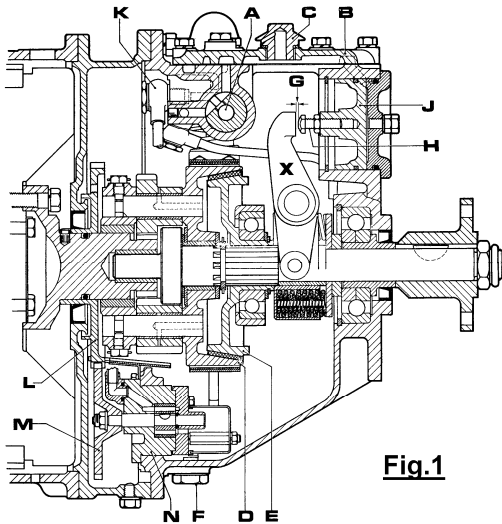
Fig.1

This is especially important with regard to the clearance on the forward drive extraction linkage (dimension "G" on fig.1) since the action of the gearbox is that the forward drive cone is held in engagement with the clutch body by a spring pack and it is only disengagement that is effected by hydraulic pressure. If the clearance at "G" is not present there is a probability that the drive cone may be held slightly out of engagement causing slip and excessive wear to the clutch lining.

A clearance at "G" may be verified by removing the filler cap "C" and inserting a screwdriver between the bolt "H" and the operating lever "X".

If this is not the case, the gearbox top cover must be removed for necessary adjustment to be made to the recommended value of $\frac{3}{32}$ " (2.38mm).

To adjust – using $\frac{3}{4}$ " a/f spanner to prevent piston "J" from rotating, loosen lock-nut ($\frac{1}{2}$ " a/f) on bolt "J". Ensuring that piston is pushed fully to rear of box, adjust position of this bolt to give recommended clearance and lock in position with nut.
