# LH150 Hydraulic Gearbox – Oil Pressure Setting

## Special Features

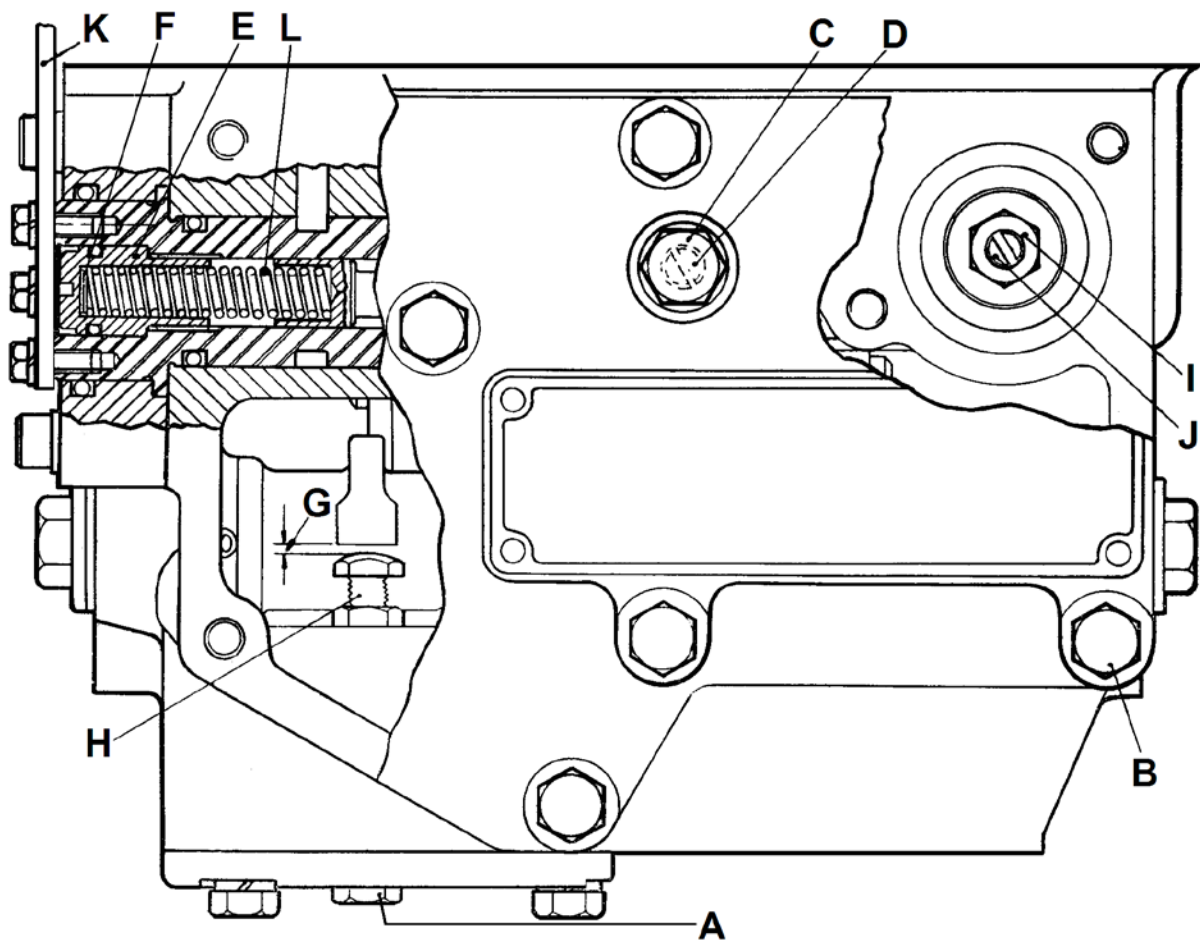
There is no high oil pressure in the ahead position and therefore the power loss in this position is small. If the hydraulic system fails the clutch remains engaged in the ahead position. The propeller shaft remains engaged with the crankshaft until the engine is started when it disengages instantly if the control is in neutral. If it is decided to free the ahead clutch with the engine stopped, as for example, for lining up the engine coupling during installation, the screw “A” is removed, replaced by screw “B” and screwed carefully until the clutch just disengages and no more.

The screws must be replaced before starting the engine.

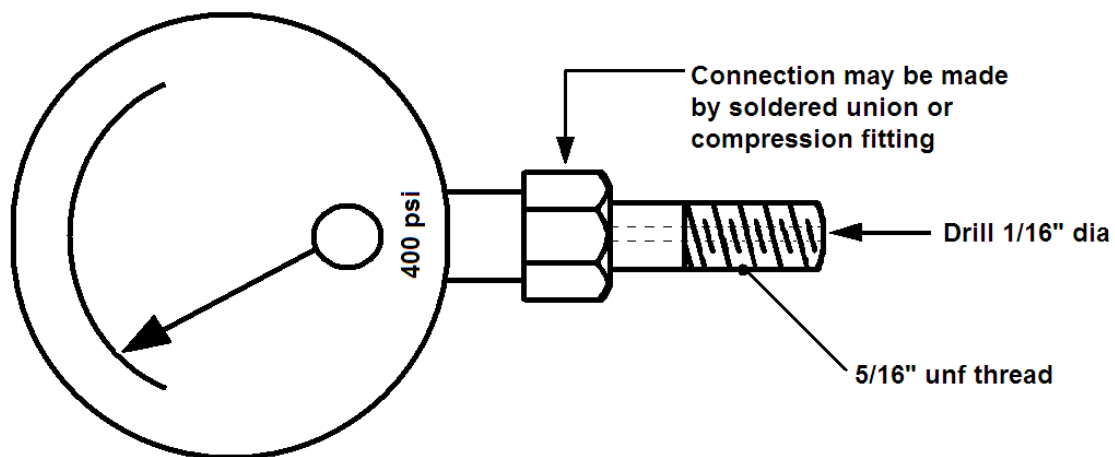
A suitable gauge fitted to a 5/16" diameter stub, drilled 1/16" & threaded 5/16"unf is most suitable for checking pressure as this can be screwed directly into the tapped hole following removal of screw "A".
