LH150 Hydraulic Gearbox – Oil Pressure Setting

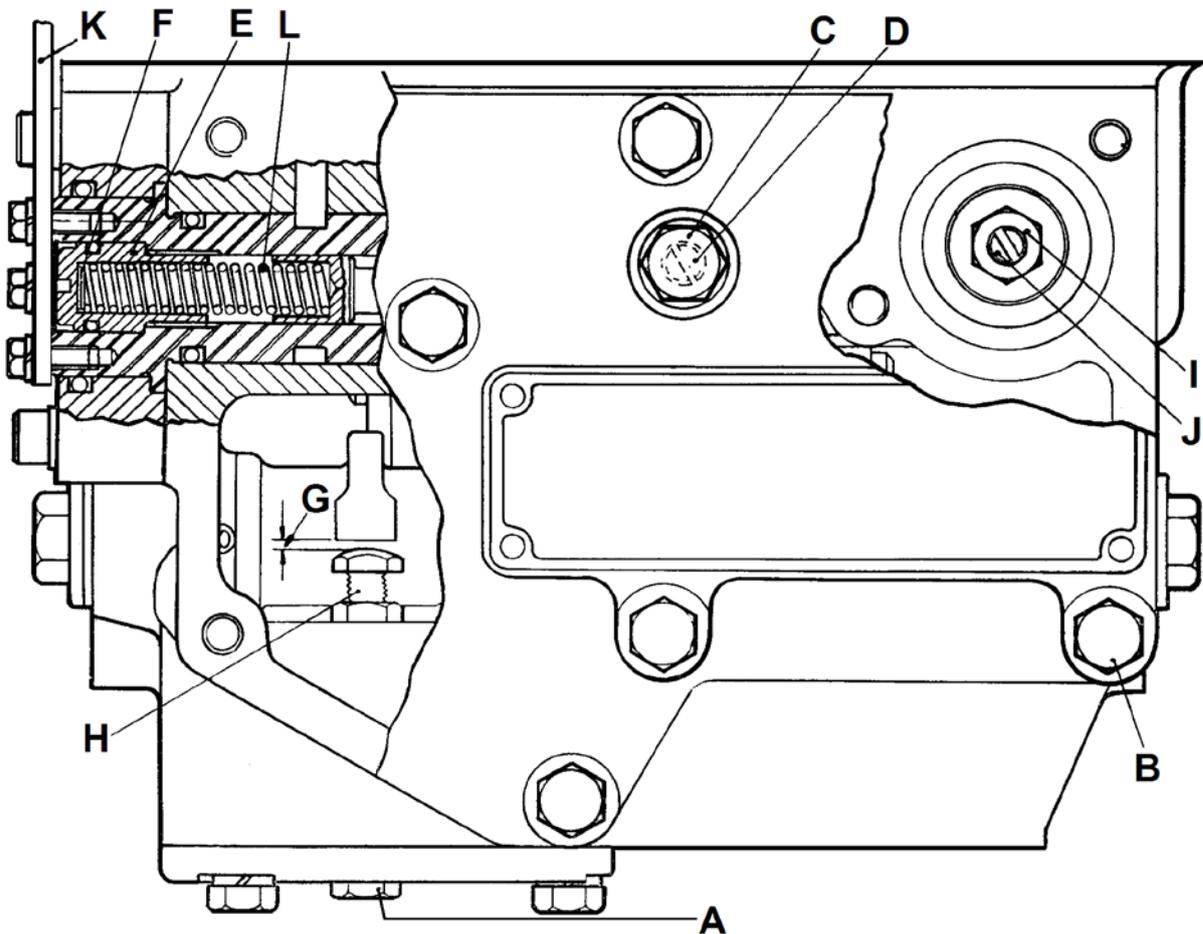
There is no high oil pressure in the ahead position and therefore the power loss in this position is small. If the hydraulic system fails the clutch remains engaged in the ahead position. The propeller shaft remains engaged with the crankshaft until the engine is started when it disengages instantly if the control is in neutral. If it is decided to free the ahead clutch with the engine stopped, as for example, for lining up the engine coupling during installation, the screw “A” is removed, replaced by screw “B” and screwed carefully until the clutch just disengages and no more.

The screws must be replaced before starting the engine.

Remove screw “A” and connect, with copper pipe having a bore of 1/16” (1.5mm) a 400psi (28kg per sq.cm.) pressure gauge.

- 1 Place control lever in neutral and run engine at about 600/800 rpm. The oil pressure should be about 250psi (17.5kg per sq.cm.)
- 2 Remove plug “C”, remove screw “D” which is under plug “C” and replace plug. Set control lever in astern position and run engine at about 600/800 rpm (propeller will not turn). The oil pressure should be about 320psi (22.5kg per sq.cm.). Replace screw and plug in original position after testing.

If pressure (2) is not correct within 10psi (0.7kg per sq.cm.) it must be adjusted by removing the relief valve adjusting plug "E" (which is under a seal behind the control lever "K") and inserting or removing shims "F" from under the spring "L". Before making any final adjustments ensure that the correct oil is used and that it is up to working temperature.

Generally these can only be dealt with by replacement of parts or tightening up the assembly. Problems can be identified by attempting to disengage the clutch using the method shown involving screws "A" & "B" above although it is important that screw "B" is not overtightened since damage to the cover or the piston itself can result. During this operation any longitudinal movement of the clutch body & mainshaft should be noted because this could be caused by the nut holding the reduction box top pinion (or coupling in direct drive boxes) being insufficiently tightened. This will result in there being insufficient movement from the extraction piston to complete the operation.

This may be done by introducing extra shims “F” under spring “L”, about .010” (0.25mm) at a time & running the engine to determine whether the cone extracts. Ideally, if available, a pressure gauge should be connected as detailed above since this pressure should not be increased beyond c.300/315psi (21/22kg per sq.cm.). If the cone still remains engaged then replacement of parts involving gearbox dismantling should be contemplated.

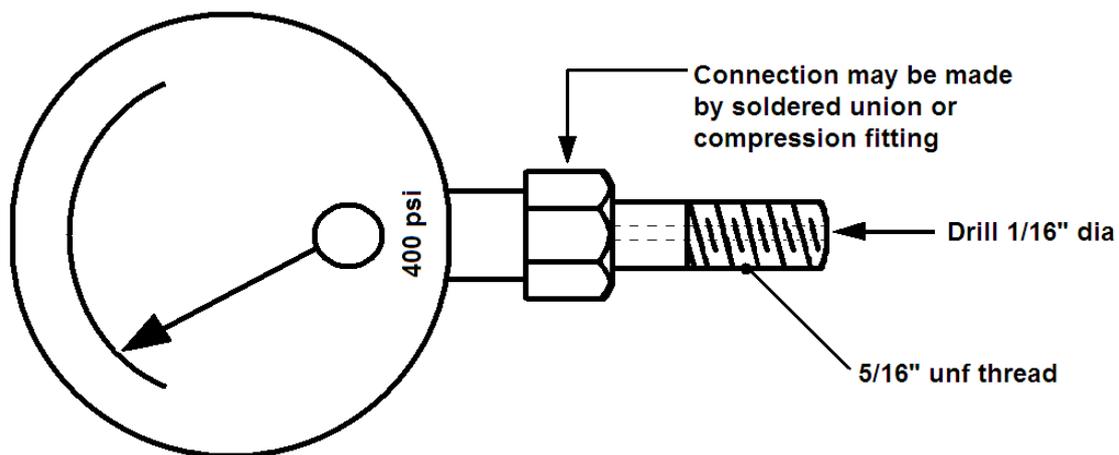
A suitable gauge fitted to a 5/16" diameter stub, drilled 1/16" & threaded 5/16"unf is most suitable for checking pressure as this can be screwed directly into the tapped hole following removal of screw "A".
